Navajo Abandoned Uranium Mine Site Screen Report

Section 29 – Conoco AUM Site

Navajo AUM Eastern Region

Weston Solutions, Inc.

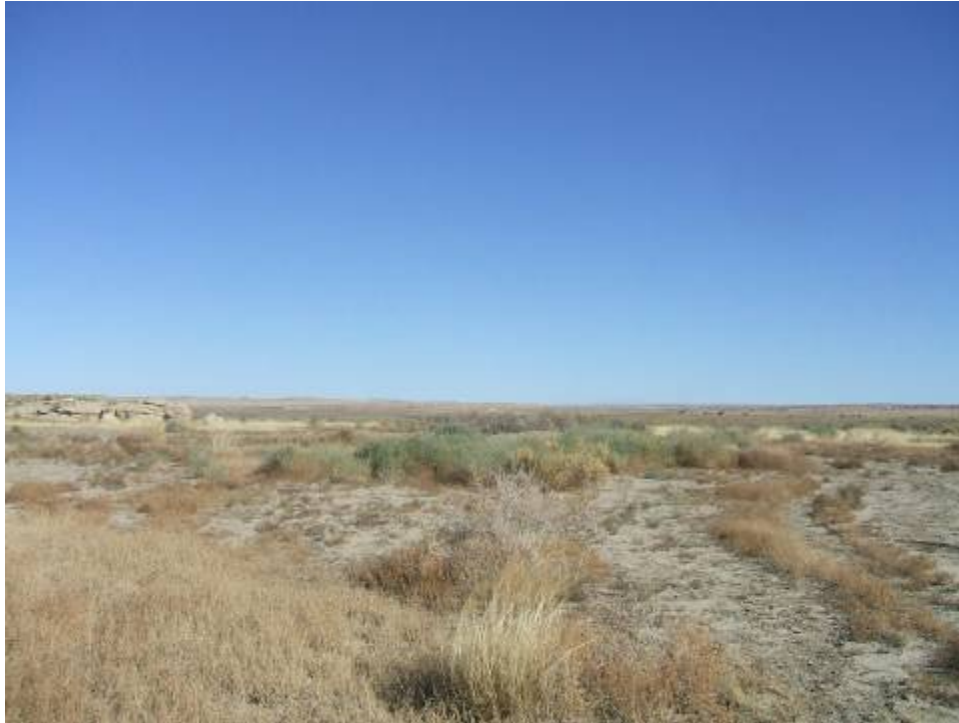
Reclamation status of the mine site is currently unknown. No visible signs of reclamation were observed. No waste piles, adits, or other mine features were observed during the site visit.

Photo 1. Section 29 – Conoco mine site, towards the east

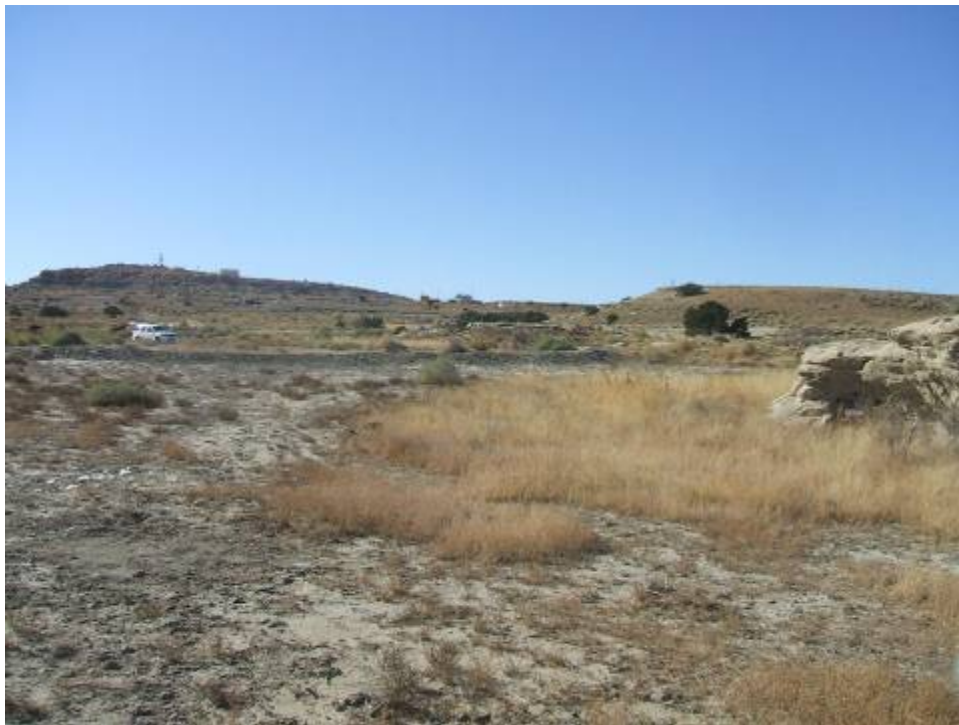
Photo 2. Section 29 – Conoco mine site, towards the west

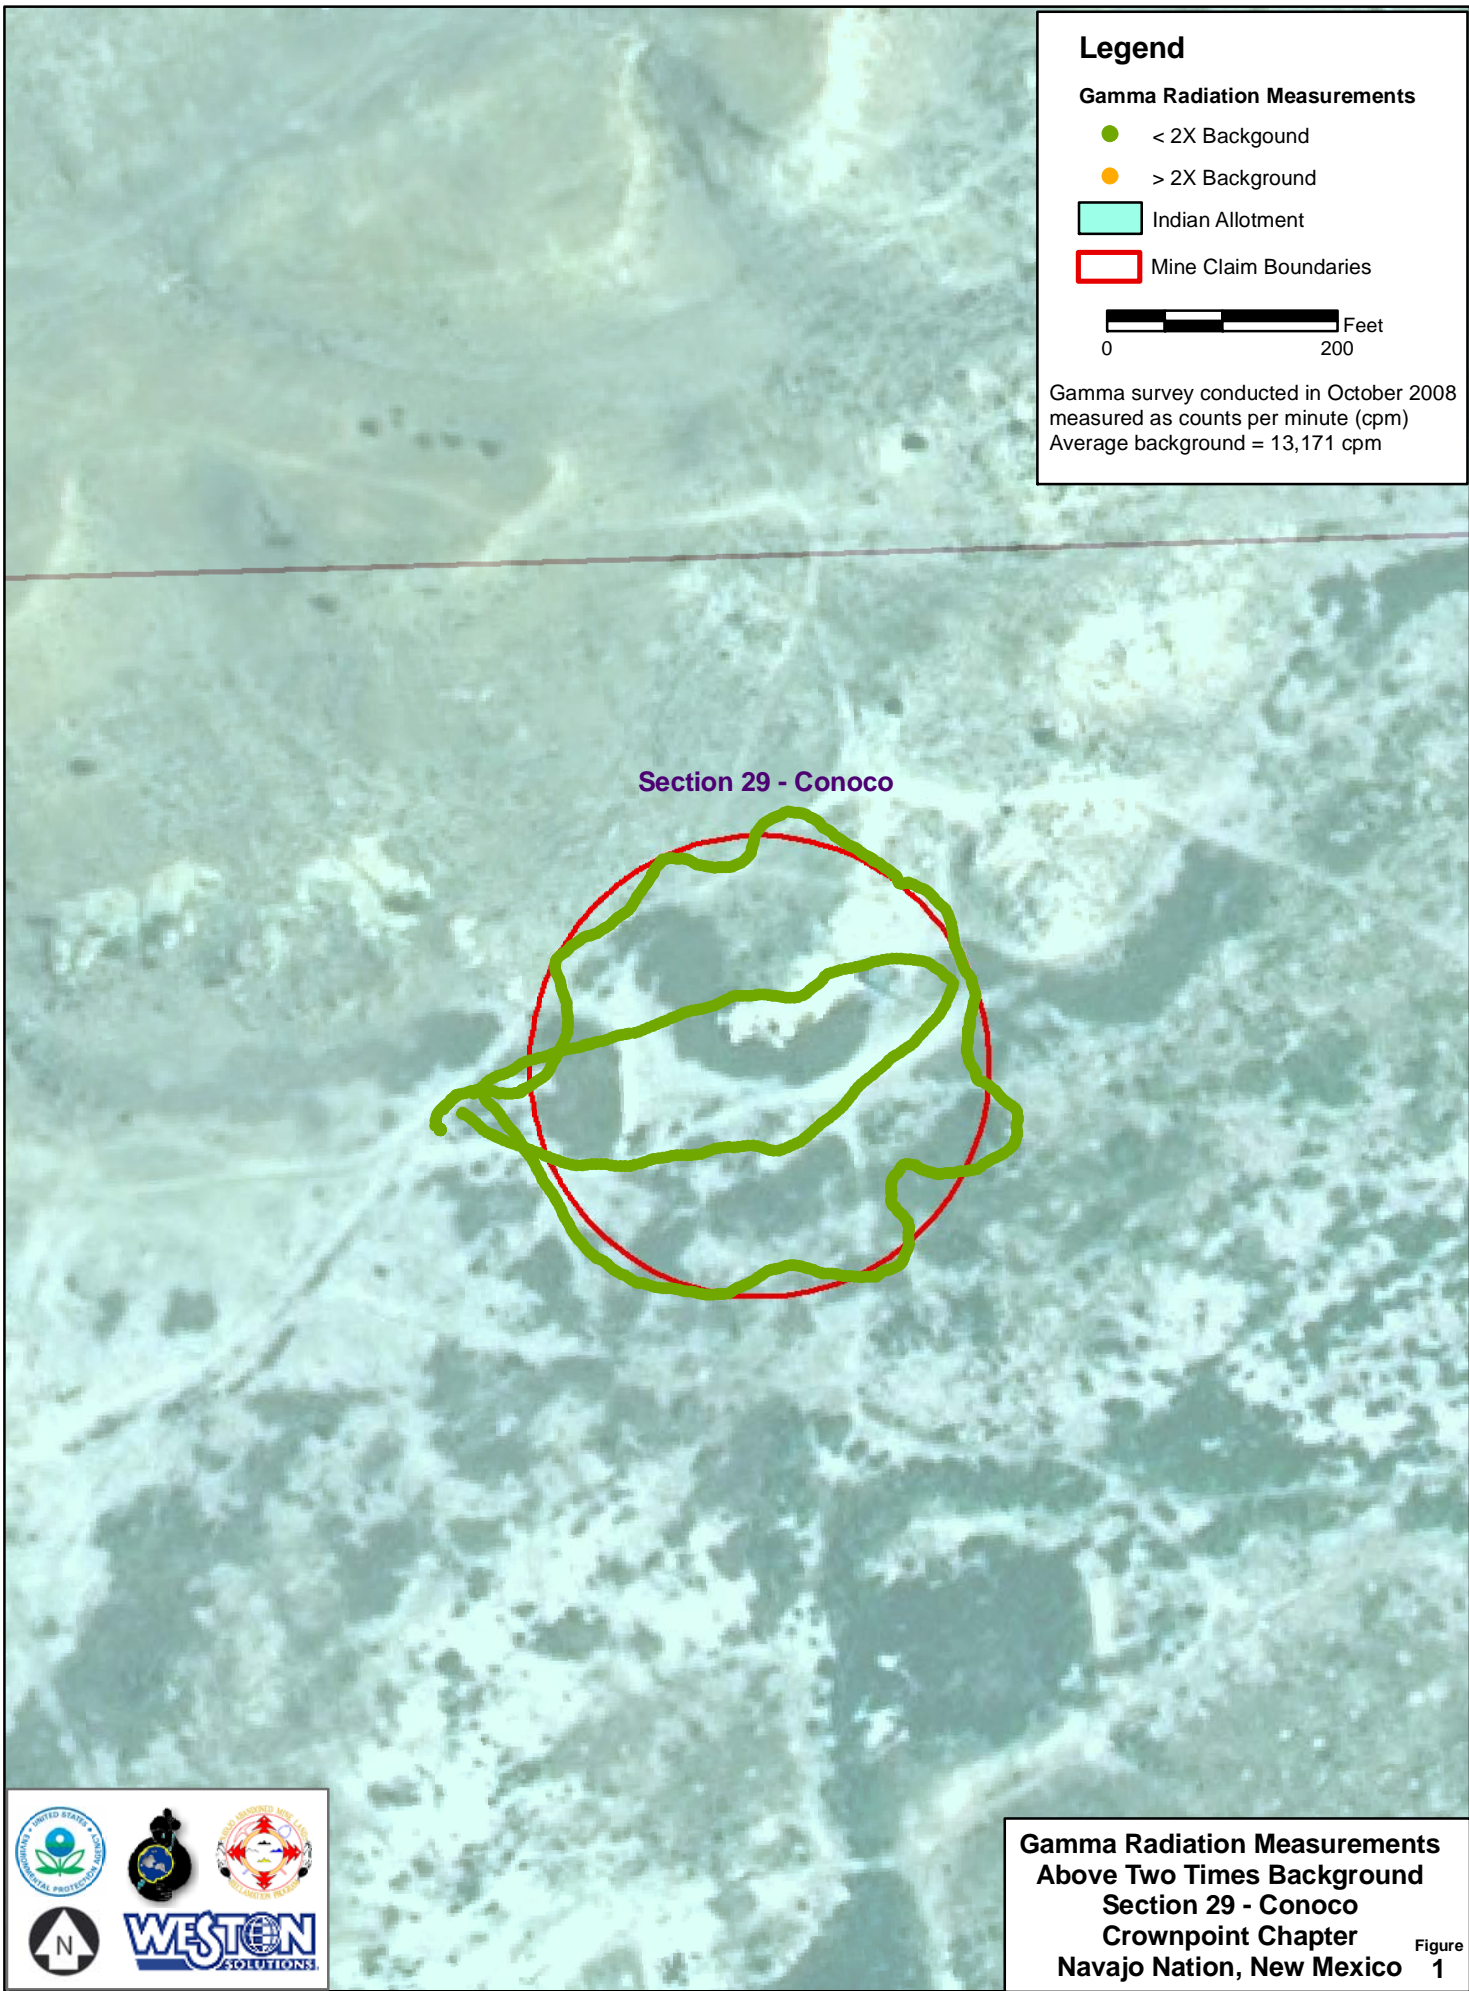
Figure 1

A total of 814 gamma radiation measurements were collected from mine sites, ranging from 10,844 cpm to 17,692 cpm. The measurements are represented in Figures 1 and 2.

Gamma survey conducted in October 2008
measured as counts per minute (cpm)
Average background = 13,171 cpm

**Gamma Radiation Measurements
Above Two Times Background
Section 29 - Conoco
Crownpoint Chapter
Navajo Nation, New Mexico**

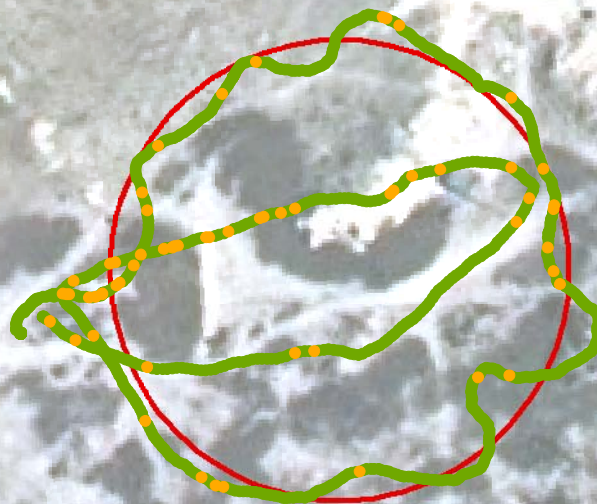
Figure 2

Gamma survey conducted in October 2008
measured as counts per minute

Gamma Radiation Measurements
Section 29 - Conoco
Crownpoint Chapter
Navajo Nation, New Mexico
